# OREGON FUEL INJECTION, INC.

## 6.5L Diagnostics

To properly diagnose a 6.5L vehicle with the DS model pump you will need a scan tool. The 1994 and 1995 are OBD1 and the 1996 through the 2000 model year is OBD2, so the diagnostic codes are different depending on the year range.

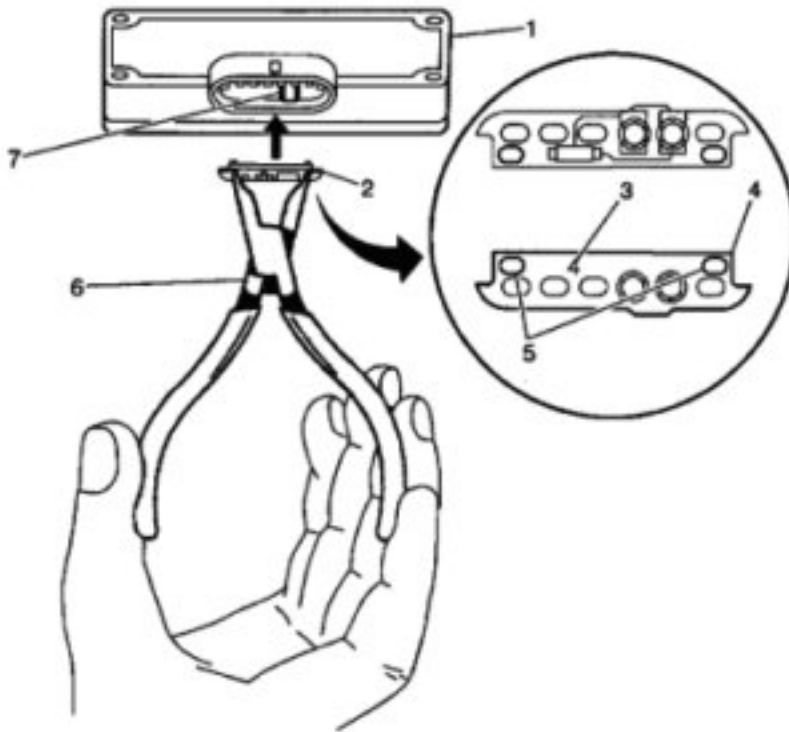
Removing the PMD requires a T15 TORX bit. Replace the heat transfer pad and use snap ring pliers to remove the calibration resistor. Install the calibration resistor into the new PMD.

1. Fuel Solenoid Driver
2. Fuel Solenoid Driver Calibrating Resistor
3. Fuel Solenoid Driver Calibrating Resistor Identification Number
4. Fuel Solenoid Driver Calibrating Resistor Index Notch
5. Fuel Solenoid Driver Calibrating Resistor Removal Holes
6. Needle Nose Pliers
7. Fuel Solenoid Driver Index Notch for Calibrating Resistor

Stanadyne has finally come out with a new PMD it is completely redesigned from the original PMD. Since the wire harness connections are different as well as the calibration resistor, the intake manifold must be removed in order to replace the PMD, because the wire harness between the PMD and the Fuel Control Solenoid will have to be replaced.

If the calibration resistor is damaged, there is an identification number on it (1 through 9) and we have them available.

**IMPORTANT: IF THE FUEL SOLENOID DRIVER CALIBRATING RESISTOR IS MISSING, DTC 56 (1994 1995) OR P1218 (1996-1998) WILL SET.**

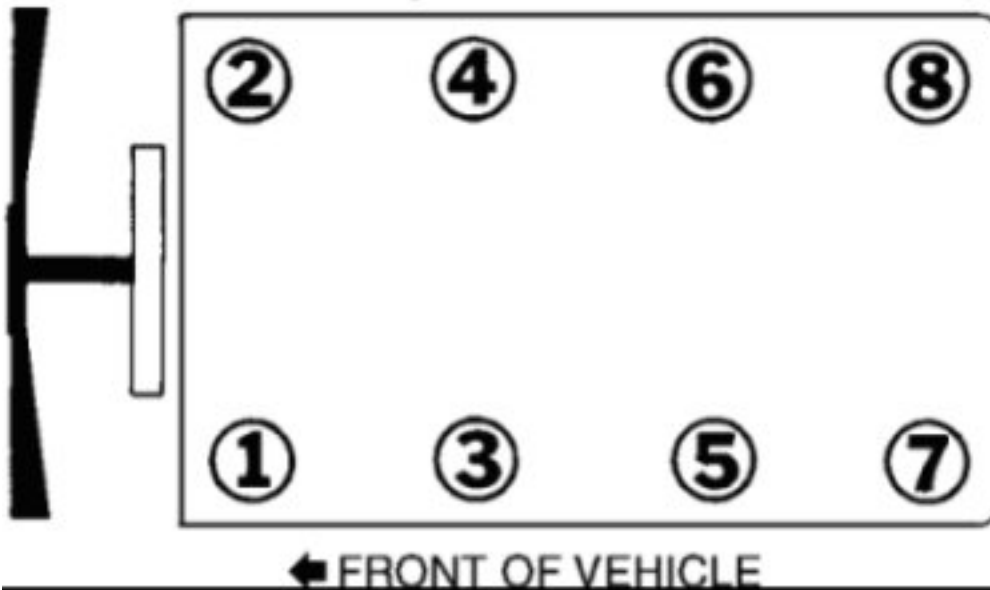
Firing Order 1-8-7-2-6-5-4-3

Firing order is
