OREGON FUEL INJECTION, INC.

6.5L Diagnostics

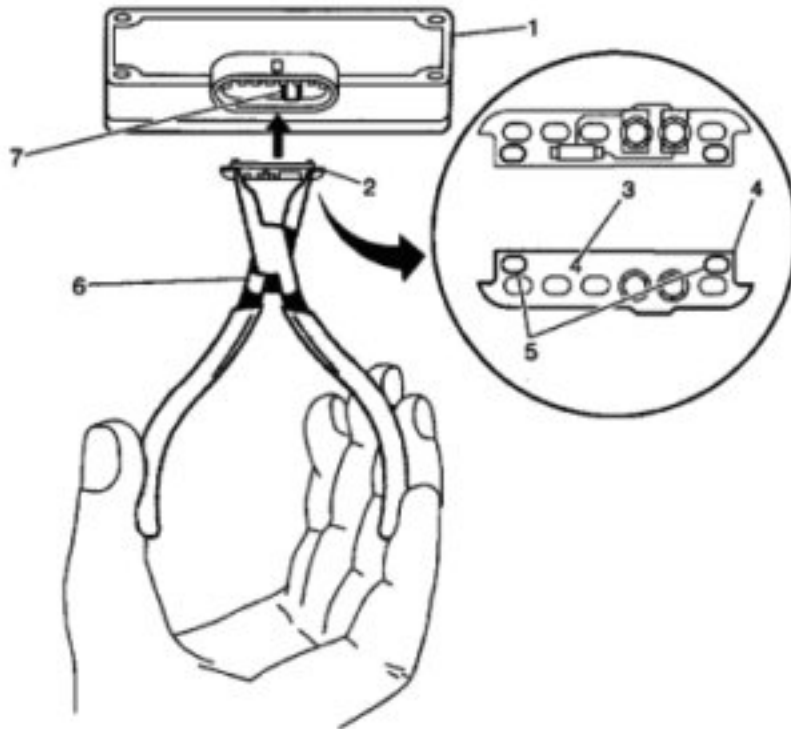
1. Fuel Solenoid Driver
2. Fuel Solenoid Driver Calibrating Resistor
3. Fuel Solenoid Driver Calibrating Resistor Identification Number
4. Fuel Solenoid Driver Calibrating Resistor Index Notch
5. Fuel Solenoid Driver Calibrating Resistor Removal Holes
6. Needle Nose Pliers
7. Fuel Solenoid Driver Index Notch for Calibrating Resistor

If the calibration resistor is damaged, there is an identification number on it (1 through 9) and we have them available.

IMPORTANT: IF THE FUEL SOLENOID DRIVER CALIBRATING RESISTOR IS MISSING, DTC 56 (1994 1995) OR P1218 (1996-1998) WILL SET.

IMPORTANT: DO NOT INSTALL THE FUEL SOLENOID DRIVER WITHOUT A NEW HEAT TRANSFER PAD. DO NOT REUSE A HEAT TRANSFER PAD. USE A NEW HEAT TRANSFER PAD ONLY. THE HEAT TRANSFER PAD IS REQUIRED TO PREVENT RAPID FAILURE OF THE FUEL SOLENOID DRIVER FROM OVERHEATING.

NOTICE: DO NOT OVER TIGHTEN FUEL SOLENOID DRIVER MOUNTING SCREWS. DAMAGE TO THE FUEL SOLENOID DRIVER WILL RESULT.

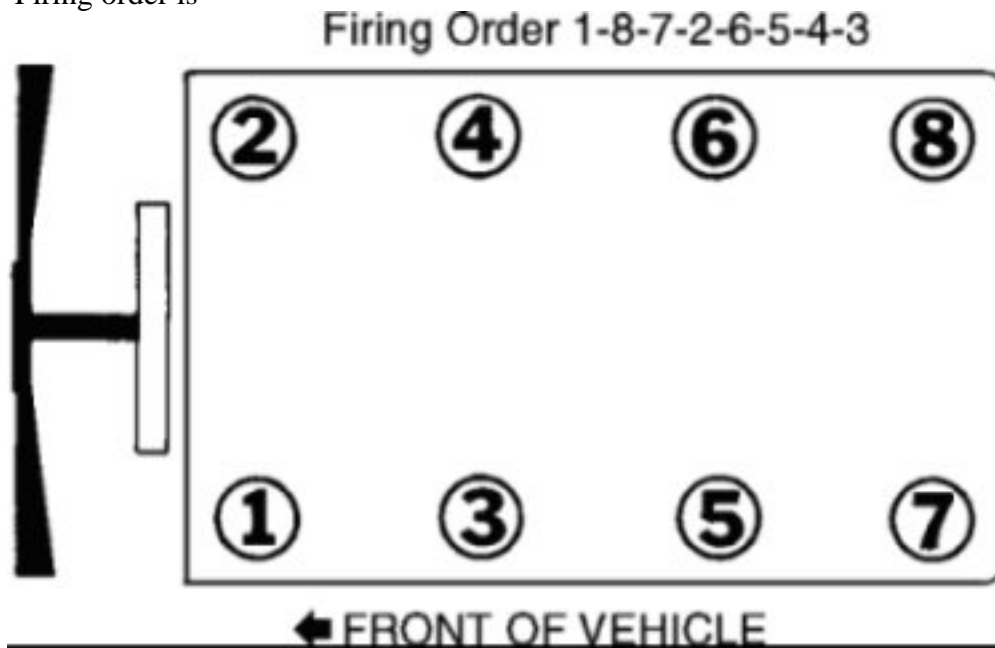
Firing order is

Misfire codes are handled differently for different years. Some misfire codes go by firing number order, in other words a misfire code for #2 would be #8 cylinder because it is the #2 cylinder in firing order. Check the service manual for the year you are working on.

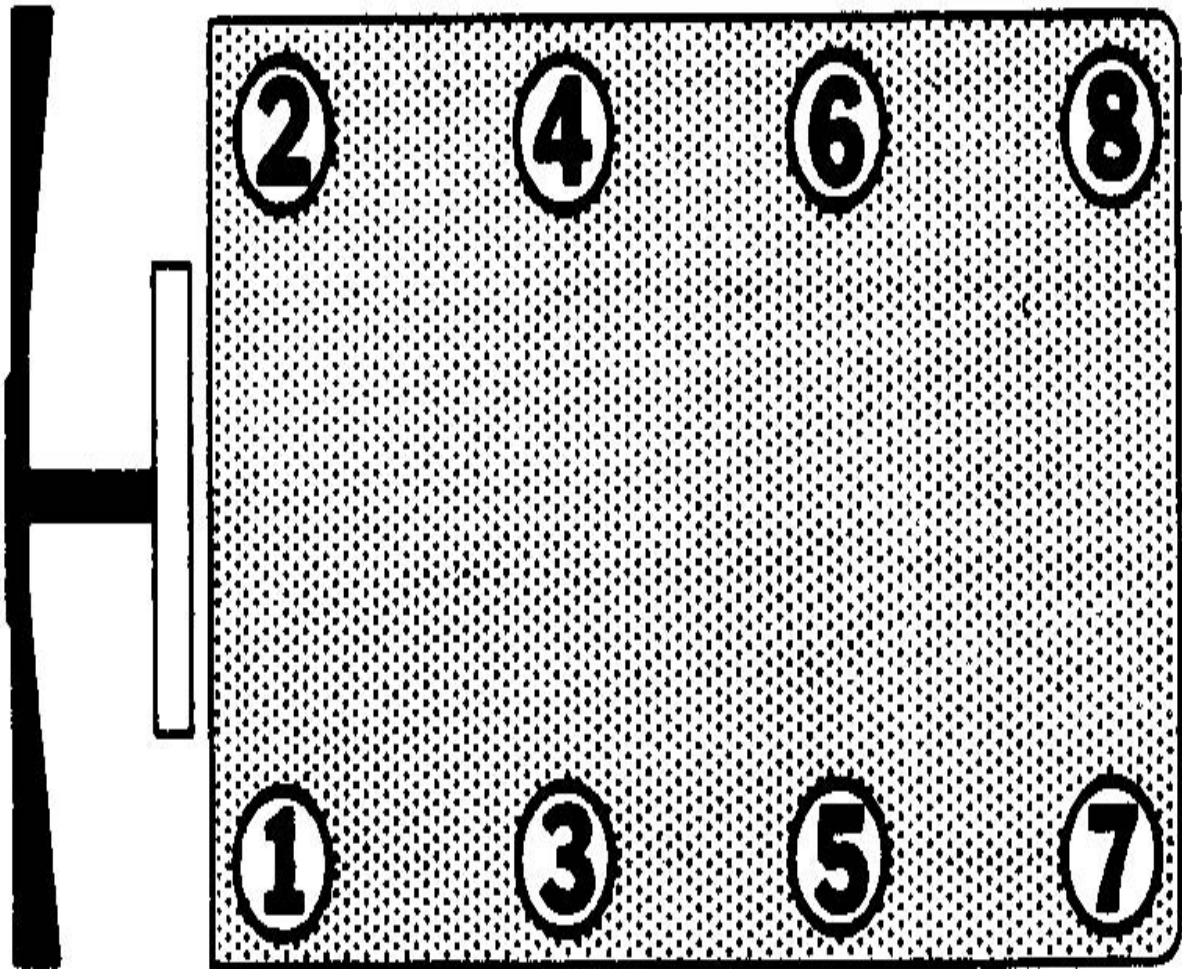
Firing Order 6.2L/6.5L

◆ FRONT OF VEHICLE

Magnetic Timing
Probe Socket

Firing Order 1-8-7-2-6-5-4-3
